Failure Analysis of Gas Turbine Blades

Mehdi Tofighi Naeem, Seyed Ali Jazayeri, Nesa Rezamahdi
K. N. Toosi University of Technology

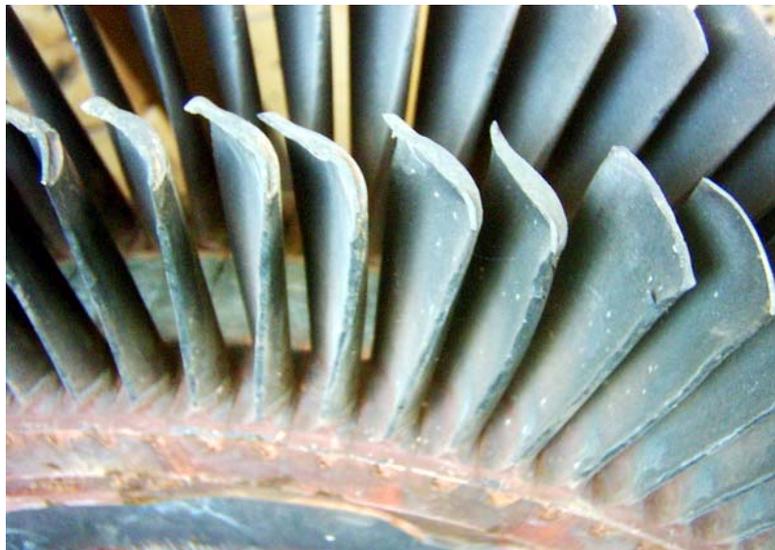
The blades used in a gas turbine were damaged during servicing. The accumulated service time of the blades is more than 10 years. The blade material is specified as IN738LC alloy (Cr: 16; Co: 8.5; Ti: 3.4; Al: 3.4; Fe: 0.3; Mo: 1.75; W: 2.6; Ta: 1.7; Si: 0.1; balance: Ni). Figures 1 and 2 show the rotor and stator of this turbine, respectively. The first stage blades were badly damaged, while the second stage blades remained relatively whole.

Figure 1: Deformation of Rotor Blades

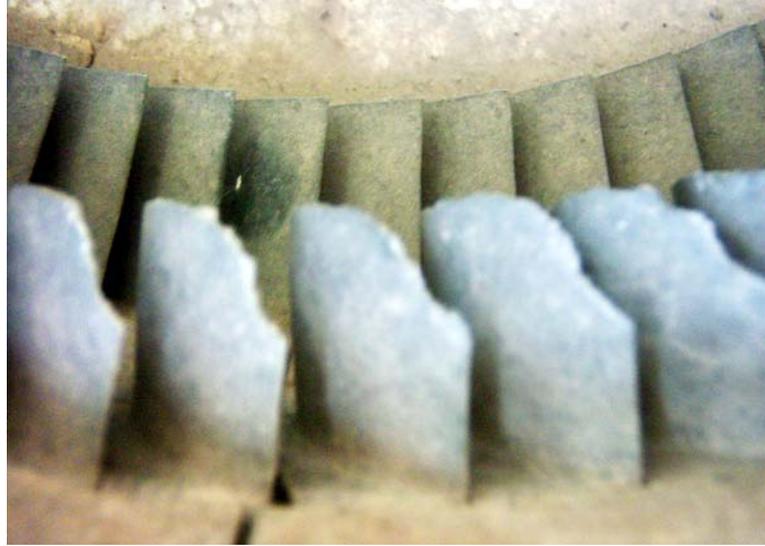
Figure 2: Failed Stator Blades

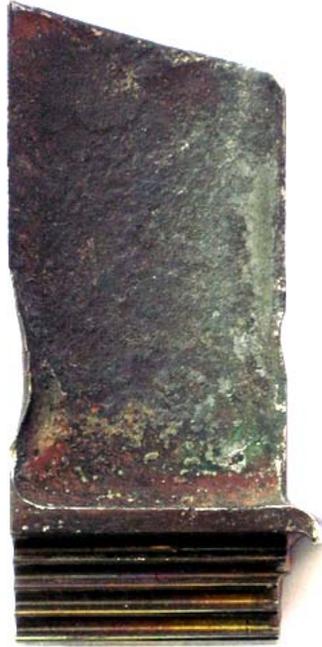
As can be seen from Figure 3, in the vicinity of the platform both sides of the blades were rough and exhibited diverse colors, especially reddish, greenish, and dark brownish regions. Using X-ray diffraction (XRD) and X-ray fluorescence (XRF), Khajavi et al. found that these colors represented the presence of iron oxides, Cr_2O_3 and NiO, as well as Na and S [28–31]. Loss of materials and thickness (that may have been caused by interaction of different mechanisms such as hot corrosion, or erosion, and creep or fatigue [30]) was observed at the whole of the blades. Also, dye penetrant inspection (DPI) testing found that there was a crack on both sides of the failed blade coating.

Figure 3: The Rough Surface Shows Diversely Colored

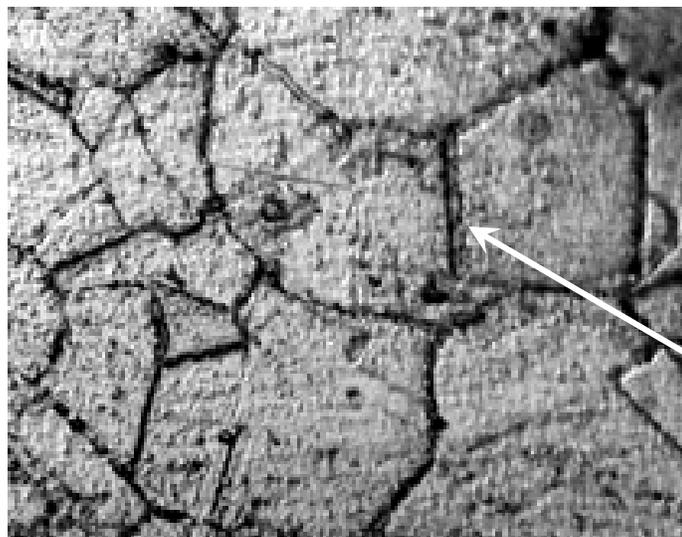
Figure 4 shows that the coarsening of grain boundary precipitates in the top section of service exposed second stage blades because of creeping degradation that was taken by optical microscopy. The distribution and morphology of strengthening phase γ' precipitates in the top section of the second stage blade, as shown in Figure 5. As can be seen from this figure,

Figure 4: Coarsened Grain Boundary Precipitates (200 \times)

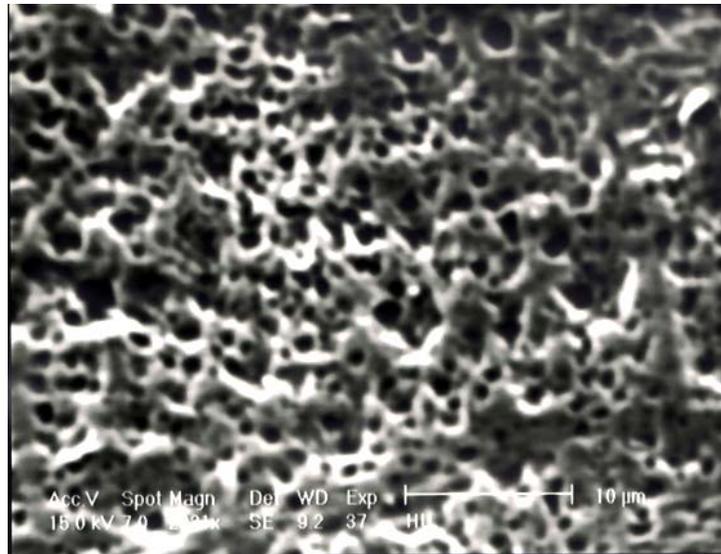
the coarsened γ' size is in the range of 0.5–2 μm in this section. Moreover, the large size coarsened γ' precipitates are surrounded by the γ' denuded zone (darker regions), devoid of secondary γ' precipitates. Figures 6 and 7 show carbides precipitation in grain boundaries that is represented in the formation of continuous films (including 39.8 percent Cr) and dispersed particles (include 9.6 percent Ti) of carbides, respectively. Carbides precipitation results in decreasing of alloy ductility and toughness.

Figure 5: The Large Size of Coarsening-Coalescence of γ' Phase

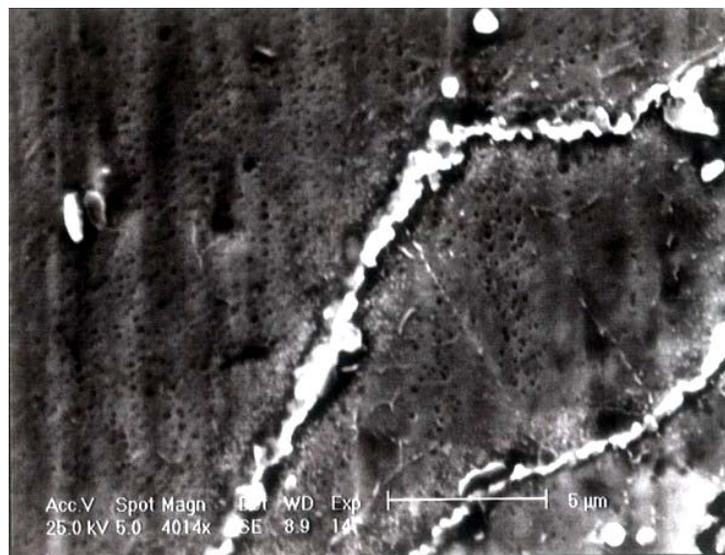
Figure 6: Continuous Films of Carbides Precipitates

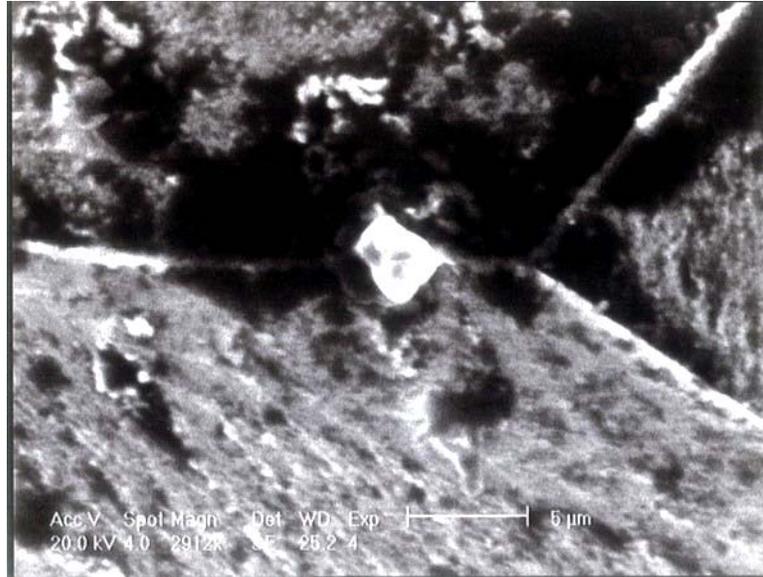
Figure 7: Dispersed Particles of Carbides Precipitates

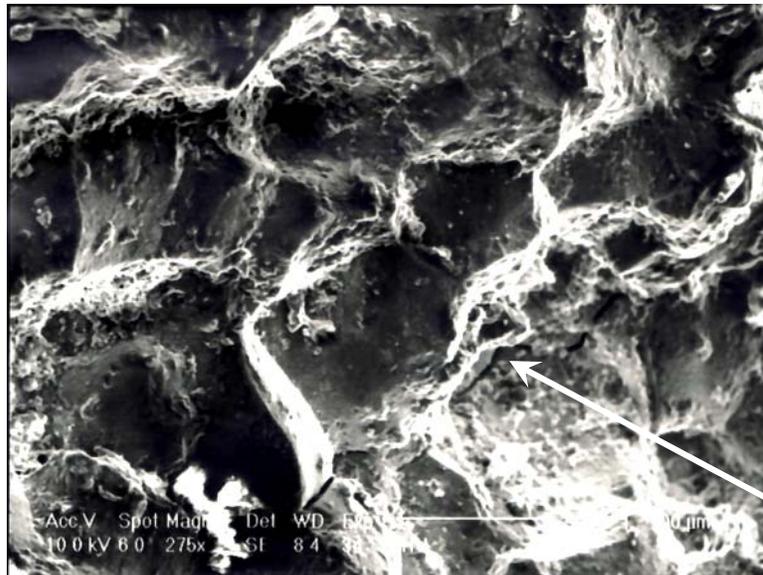
There were a large number of cracks at different regions of blades because of operation at high temperatures and stresses over a long period of time. Some of these cracks are shown in Figures 8–11. In Figure 8, we observe an intergranular crack on fracture surface. The appearance of the fracture surface in Figure 9 resembles a dimple-like fracture. The dimple-like appearance can be attributed to the microcavities, which could be related to intergranular decohesion of carbides [29, 32]. These microcavities serve as the origin of a creep failure mechanism [29, 33, 34].

Figure 8: Intergranular Fracture Morphology (There is a crack on fracture surface.)

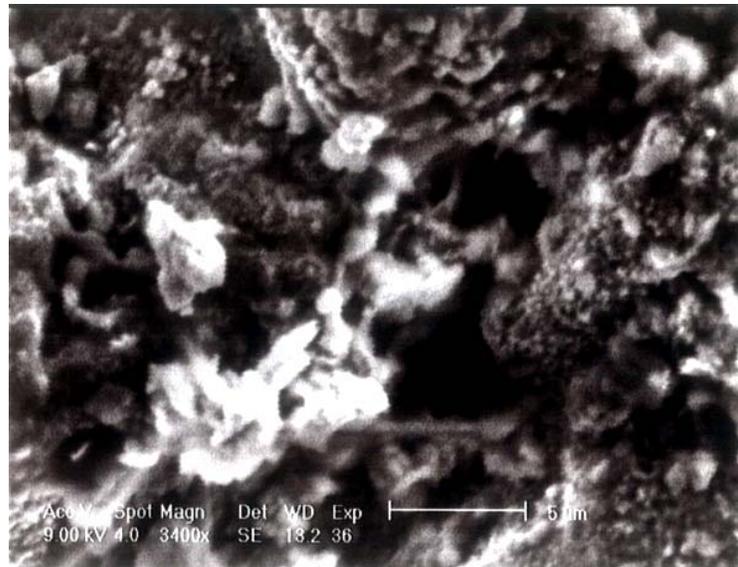
Figure 9: Dimple-like Microcavities Found on Fracture Surface

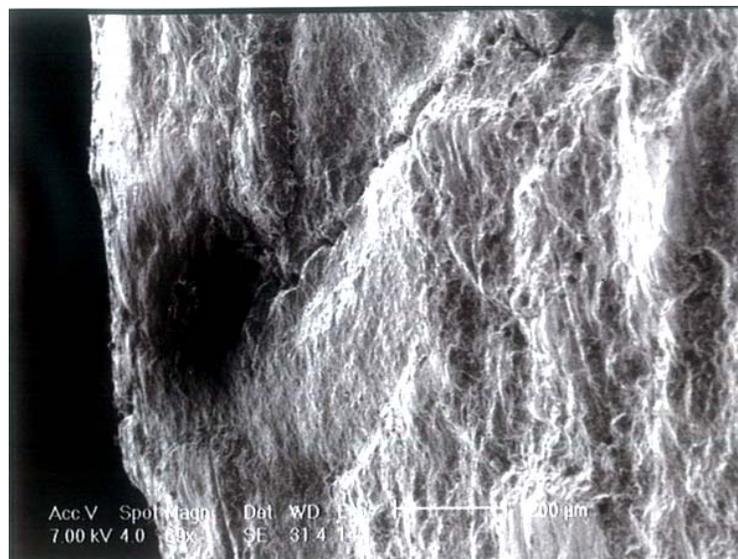
Also, we observed an intergranular crack on the first stage blade coating (Figure 10) and several intergranular cracks that were located on transverse section of the blade surface (Figure 11). The coating crack initiation was probably due to a thermal fatigue mechanism, as a result of high thermal transient loads (i.e., trips, start-ups, and slow-downs) and crack grain boundary initiation and propagation in the substrate by a creep mechanism (high steady state loads) [33].

Figure 10: Intergranular Crack on the Coating

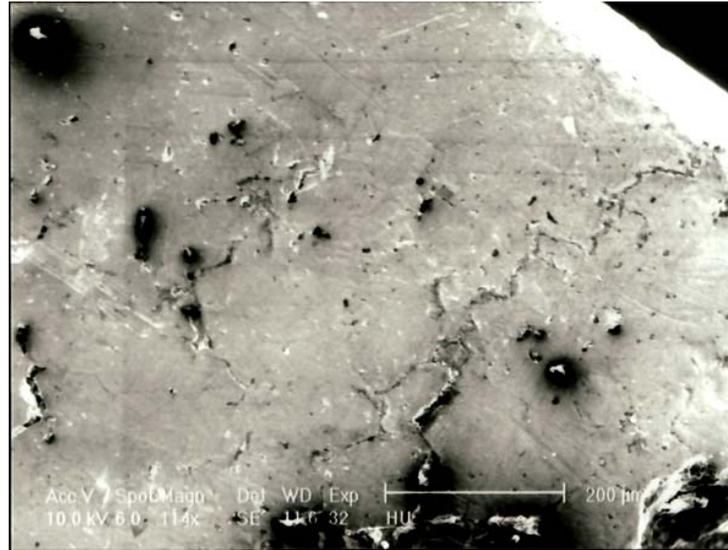
Figure 11: Several Intergranular Cracks on Transverse Section of the Blade Surface

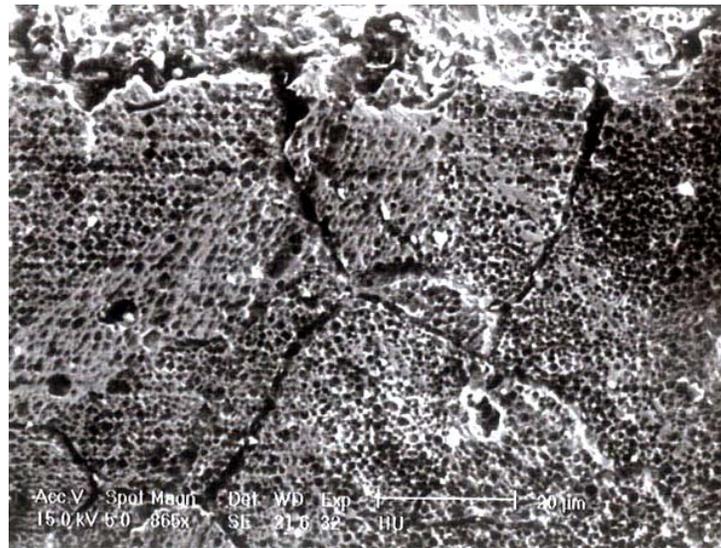
As the other result of the creep failure mechanism, we found grain detachment in the second stage blade that is shown in Figure 12. As seen in this figure, there were several macrocracks on grain boundaries.

Figure 12: Several Macrocracks on Grain Boundaries Due to Creep Mechanism

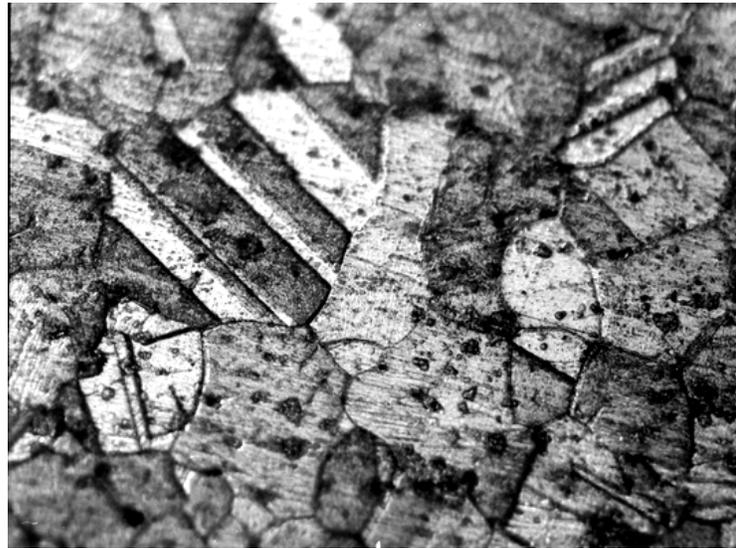
twins [35]. In this study, many annealing twins (Figure 13) were observed at different regions.

Figure 13: Annealing Twins Taken by Optical Microscopy (200×)

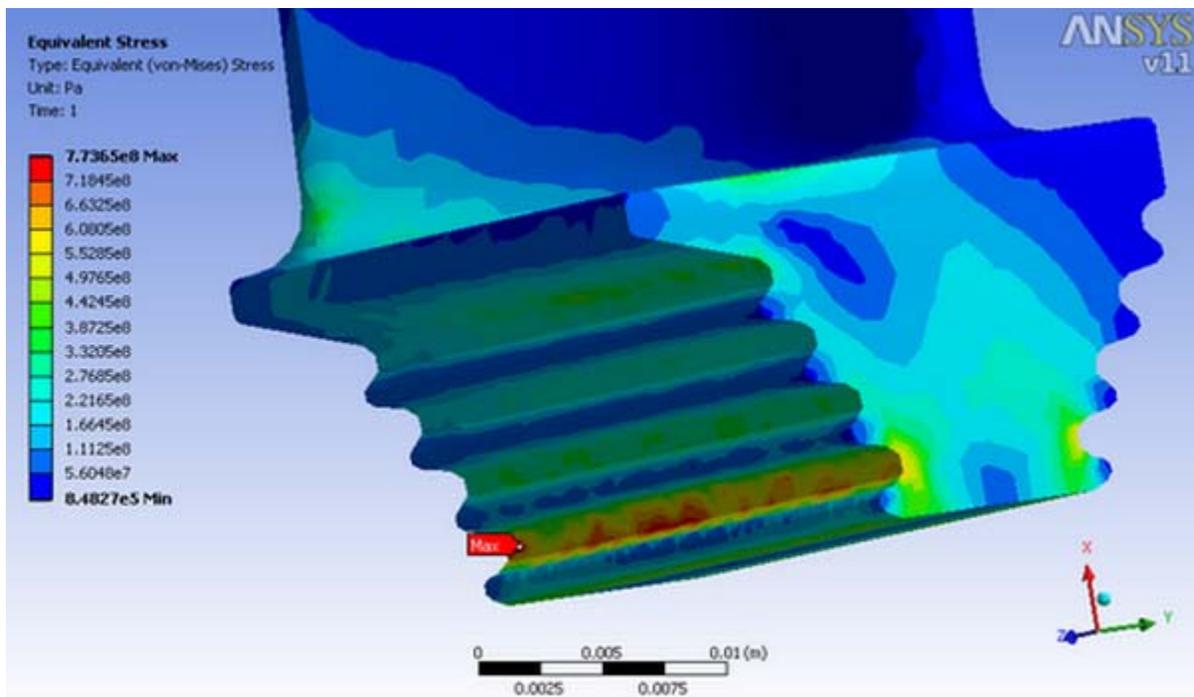
Temperature and pressure contours showed consistence with real conditions (Figures 14, 15, 16, and 17). Note that at these figures, the stator and rotor blades were located left to right, respectively. Figures 18 and 19 show the magnitude and direction of flow velocity by use of velocity vectors and streamlines, respectively. The stress analysis simulated the steady state behavior of the rotor first stage blade under service conditions where the centrifugal load, gas pressure load, and thermal expansion are present. The equivalent stresses and total deformation plots for a blade are shown in Figures 20 and 21, respectively. The peak stress of the blade occurred at the bottom firtree, not at the topsection of the blade where failure occurred. It is, therefore, unlikely that blade failure was directly related to centrifugal and gas loading.

The cause of the rotor blade failure may be increases in blade length and contact between blade tip and casing as a consequence of creep after an extended period in service.

Figure 20: Resultant Stress Distribution for the Rotor Blade

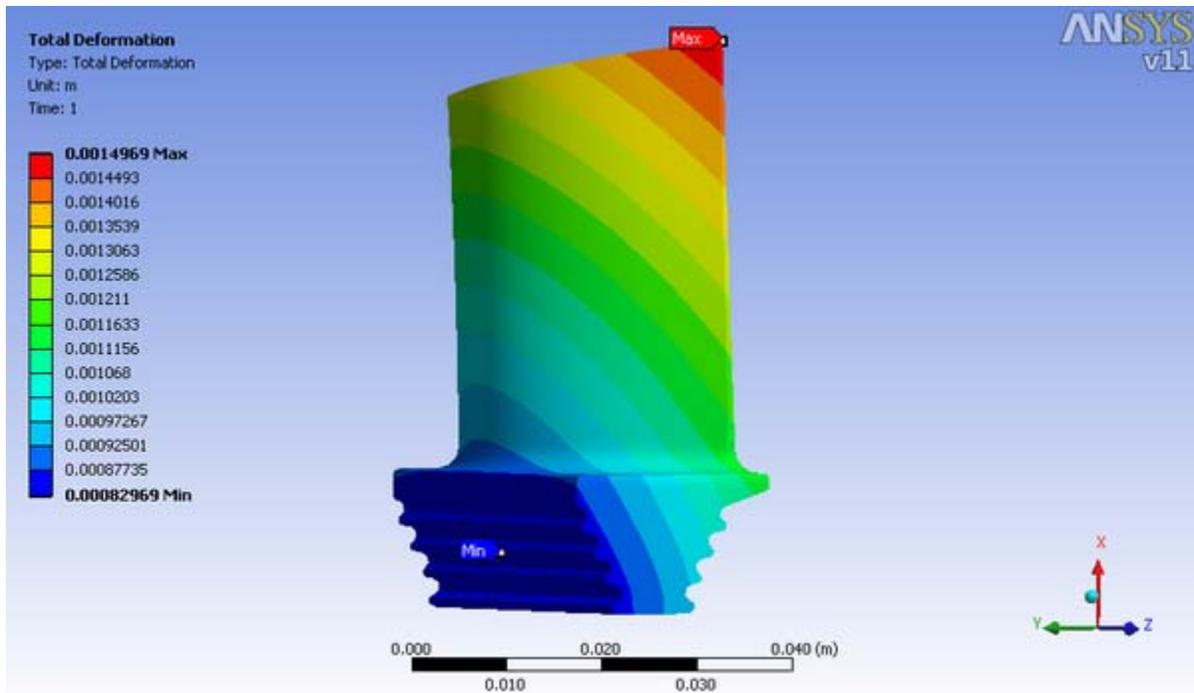
Figure 21: Total Deformation of the Rotor Blade
