## Analysis of Metallurgical and Mechanical Failure of a Centrifugal Compressor

Nesa Rezamahdi, Seyed Ali Jazayeri, Mehdi Tofighi Naeem

K. N. Toosi University of Technology, Iran

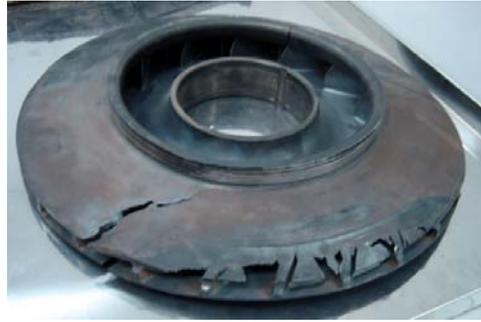
After the compressor disassembling and the rotor removal, it was evident that the second stage impeller was catastrophically broken. A visual inspection of the second stage impeller revealed the presence of many cracks, on both the disc and cover (Figures 1 and 2).

Figure 1: Fracture on Cover

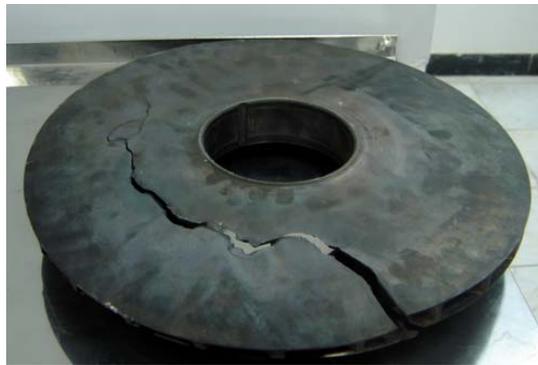
Figure 2: Fracture on Disc

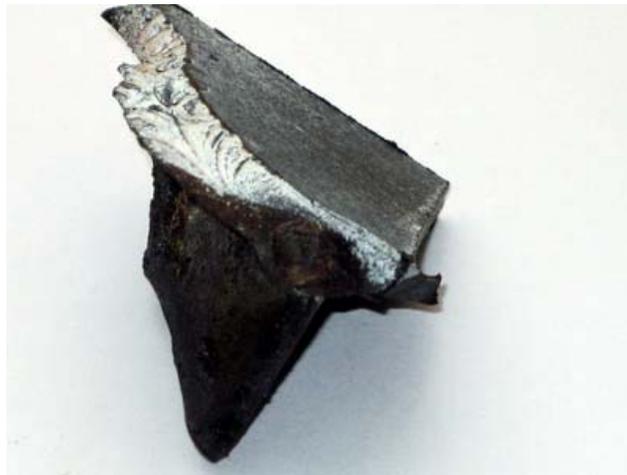
Fortunately, the crack often leaves a series of fracture markings in its wake that may indicate the relative direction of crack motion. For example, the curved lines (called chevron markings) that seem to converge near mid-thickness of the fracture surface (shown in Figure 3) have been shown to point toward the crack origin. It is believed that, within the material, localized separations ahead of the crack grow back to meet the advancing crack front and form these curved tear lines. All one needs to do is follow the chevron arrow. When a crack initiates in a large component, it sometimes branches out in several directions as it runs through the structure. Although the chevron markings along each branch will point in different directions relative to the component geometry, it is important to recognize that the different sets of chevron markings all point in the same relative direction—back toward the origin. Chevron markings grow radially from an internally located origin [6].

Figure 3: One Sample of Impeller and Chevron Markings on its Fracture Surface

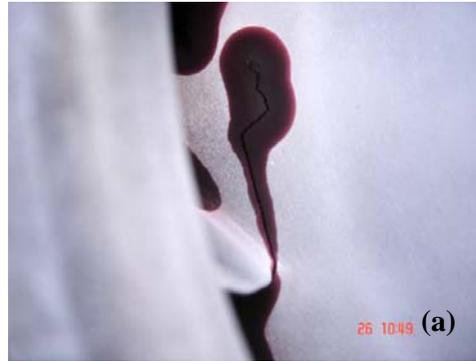
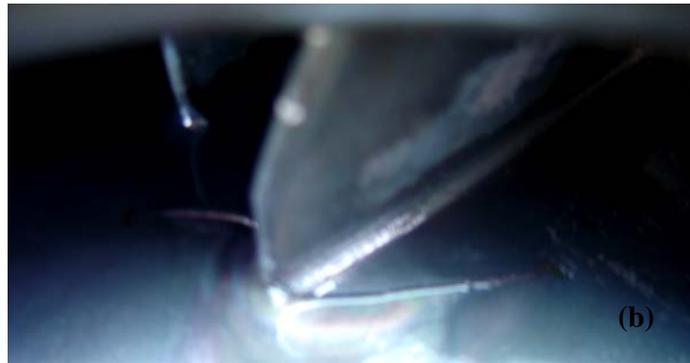
The assembly of the compressor was dismantled. Dye penetrant inspection (DPI) and magnetic particles tests were carried out to detect the defects on the impeller (Figure 4). Since cracks and failures were so clear, even without using these tests, all of them were noticeable.

Figure 4: Crack around the Blade, (a) DPI, (b) Magnetic Particles

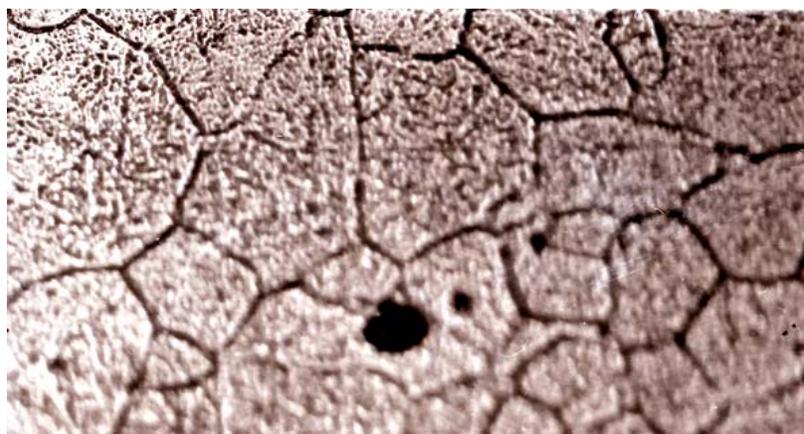
Also (as can be seen in Figure 5), there are macrocracks on grain boundaries. They are the resultant of creep mechanisms. First, isolated cavities are formed on boundaries; then, the quantity of them increases and oriented cavities are made. Next, these cavities join together and form microcracks and macrocracks, respectively.

Figure 5: Macrocracks Have Formed on Grain Boundaries (200×)

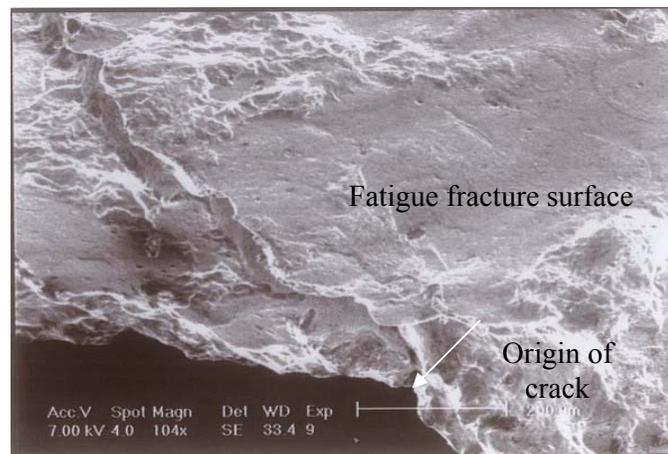
The fatigue fracture surface of the impeller was cut to be observed by SEM. As shown in Figure 6, the fracture surface created by the fatigue crack is smooth, but the initial crack looks coarse [7]. Figure 7 shows a part of cover coating that was removed due to fatigue. Figure 8 displays cracks on the fracture surface. Figure 9 shows fatigue striations, and in Figure 10, the detachment of grains due to the creep mechanism is clear.

Figure 6: Fatigue Fracture Surface

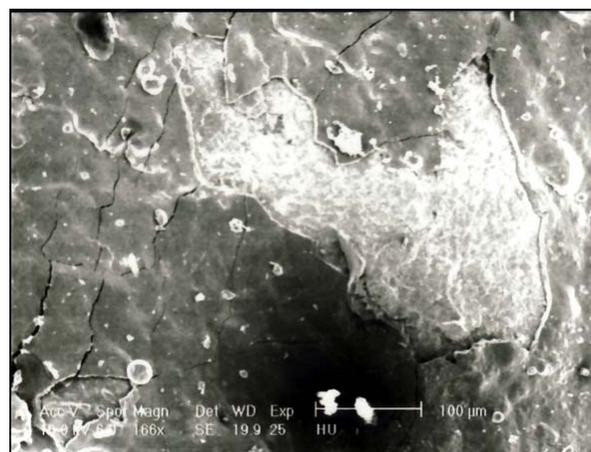
Figure 7: Fatigue Cracks on Cover Coating

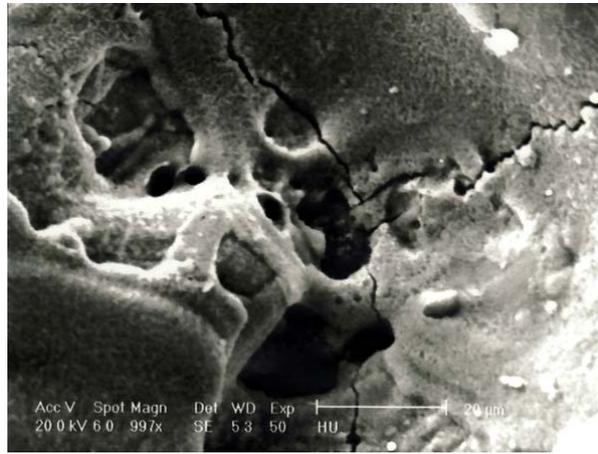
Figure 8: Cracks on Fracture Surface

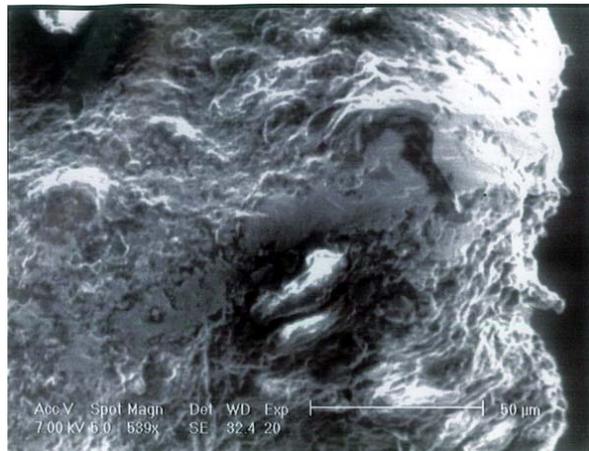
Figure 9: Fatigue Striations

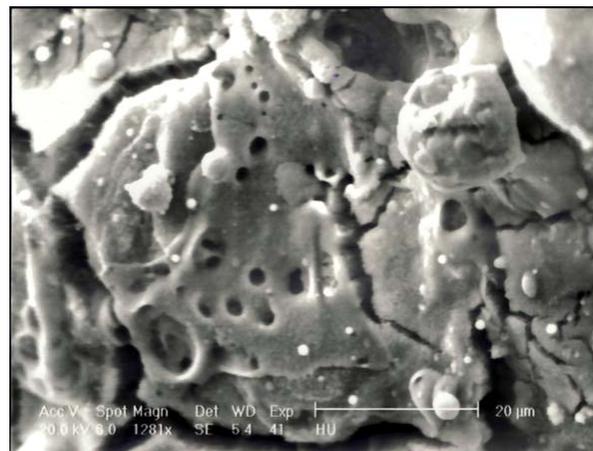
Figure 10: Detachment of Grains Due to Creep Mechanisms  
. Proceedings of The 2008 IAJC-IJME International Conference  
ISBN 978-1-60643-379-9

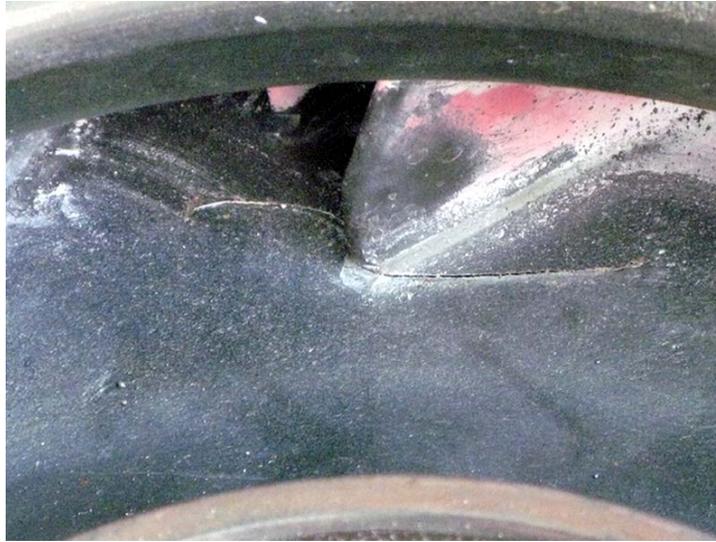
Apparently, velocity values change from 90 m/s at inlet to 137 m/s at outlet. In Figures 15 and 16, velocity streamlines are observed. By making a comparison between Figures 16, 18, and 19, we found that there is a positive agreement between practical and analytical results. In practice, it was observed that critical points were put at the junction of the disc and blade. On the other hand, we analyzed the impeller using software, and the resultant was similar. Because of the high flow velocity (approximately 169 m/s) at these points and mechanical design (vertical connection) between the blade and disc, the result is a zone of stress concentration. The stress contour is shown in Figure 19, and the position of maximum stress is clear in Figure 20. By considering pressure and temperature contributions, we understand that these parameters increase along the flow path. Also, observing velocity magnitude shows us that its magnitude increases at outlet. These results have a good agreement with real conditions.

Figure 18: Crack at the Junction of Blade and Disc

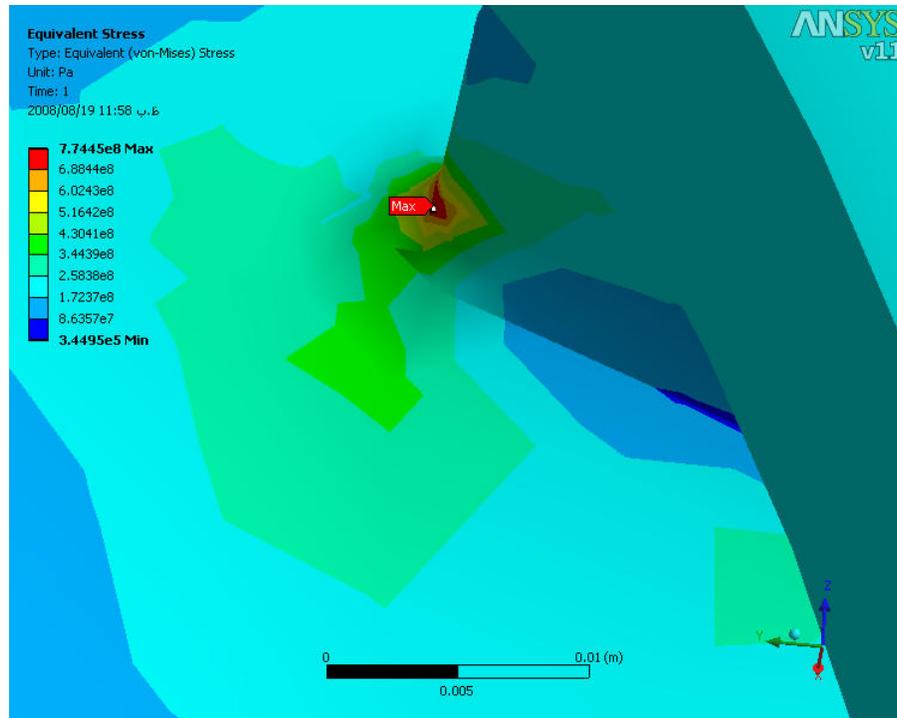
Figure 20: Stress Concentration
