Failure Analysis of Gas Turbine Blades

Mehdi Tofighi Naeem, Seyed Ali Jazayeri, Nesa Rezamahdi
K. N. Toosi University of Technology

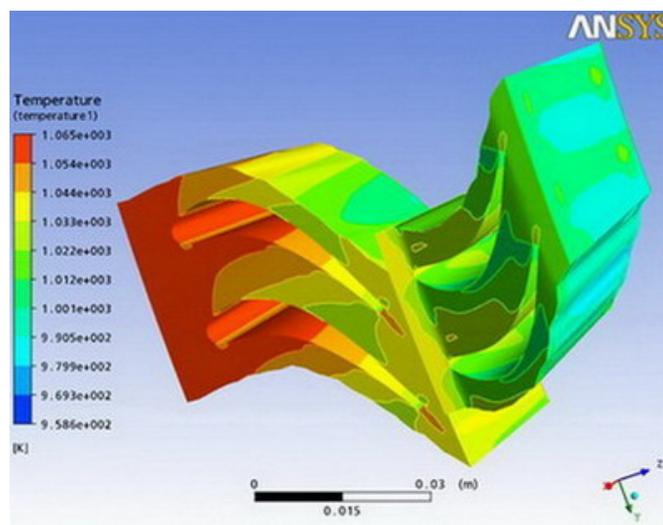
Figure 14: Fluid Flow Temperature Distribution around the First Stage Blades

Temperature and pressure contours showed consistence with real conditions (Figures 14, 15, 16, and 17). Note that at these figures, the stator and rotor blades were located left to right, respectively. Figures 18 and 19 show the magnitude and direction of flow velocity by use of velocity vectors and streamlines, respectively. The stress analysis simulated the steady state behavior of the rotor first stage blade under service conditions where the centrifugal load, gas pressure load, and thermal expansion are present. The equivalent stresses and total deformation plots for a blade are shown in Figures 20 and 21, respectively. The peak stress of the blade occurred at the bottom firtree, not at the topsection of the blade where failure occurred. It is, therefore, unlikely that blade failure was directly related to centrifugal and gas loading.
