## Analysis of Metallurgical and Mechanical Failure of a Centrifugal Compressor

Nesa Rezamahdi, Seyed Ali Jazayeri, Mehdi Tofighi Naeem

K. N. Toosi University of Technology, Iran

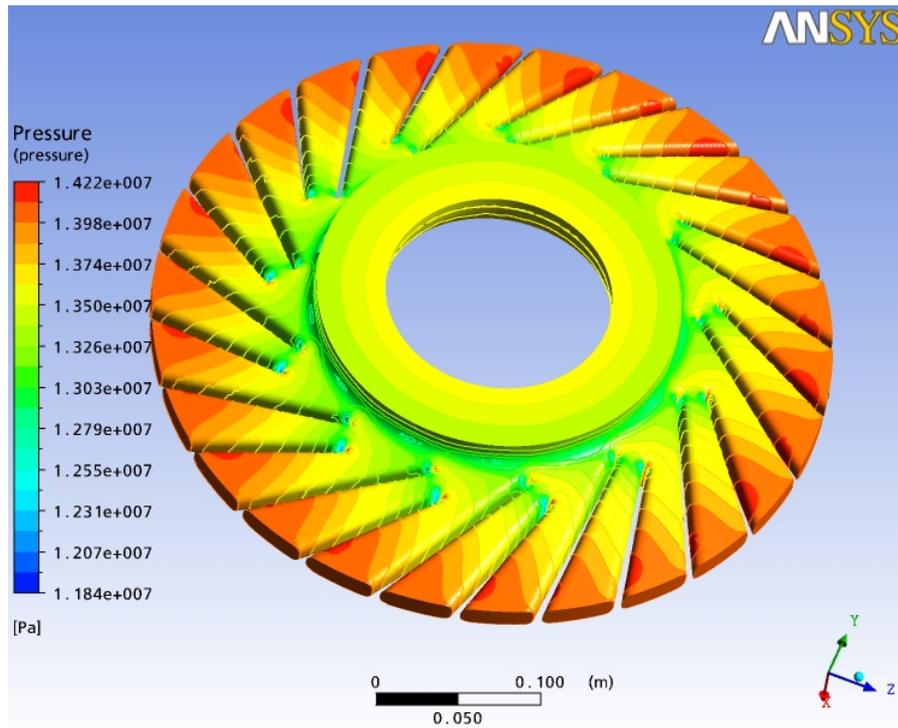
Figure 13: Flow Pressure Contour

From Figure 13, it is clear that pressure values vary from 134 bars at inlet to 140 bars at outlet. These changes were made layer-by-layer in gas flow. Temperature variations are similar to pressure, too. Temperature magnitude has changed from 326 to 328.5 K (Figure 14).

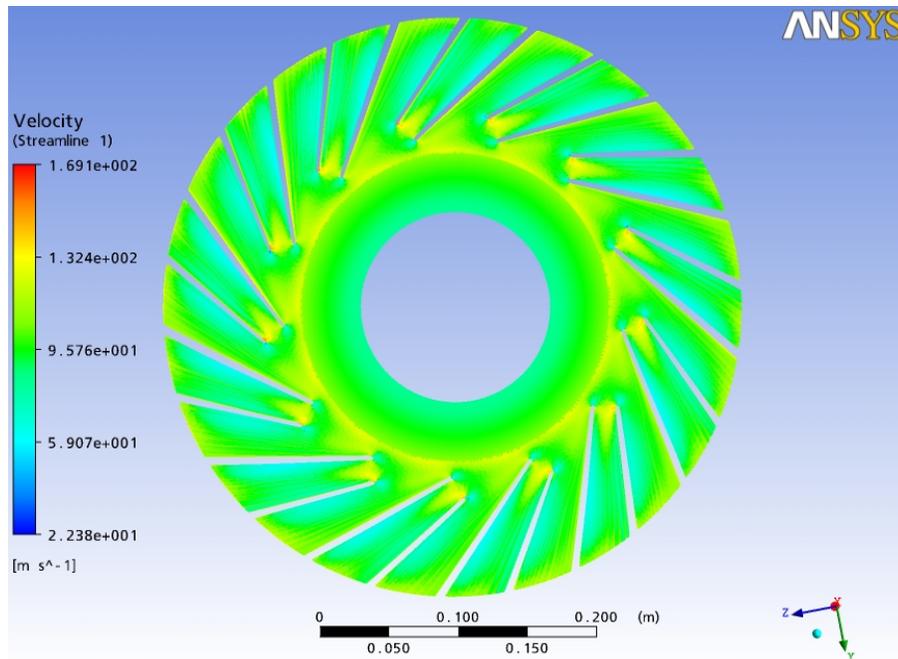
Figure 15: Velocity Streamline (Top View)

Apparently, velocity values change from 90 m/s at inlet to 137 m/s at outlet. In Figures 15 and 16, velocity streamlines are observed. By making a comparison between Figures 16, 18, and 19, we found that there is a positive agreement between practical and analytical results. In practice, it was observed that critical points were put at the junction of the disc and blade. On the other hand, we analyzed the impeller using software, and the resultant was similar. Because of the high flow velocity (approximately 169 m/s) at these points and mechanical design (vertical connection) between the blade and disc, the result is a zone of stress concentration. The stress contour is shown in Figure 19, and the position of maximum stress is clear in Figure 20. By considering pressure and temperature contributions, we understand that these parameters increase along the flow path. Also, observing velocity magnitude shows us that its magnitude increases at outlet. These results have a good agreement with real conditions.

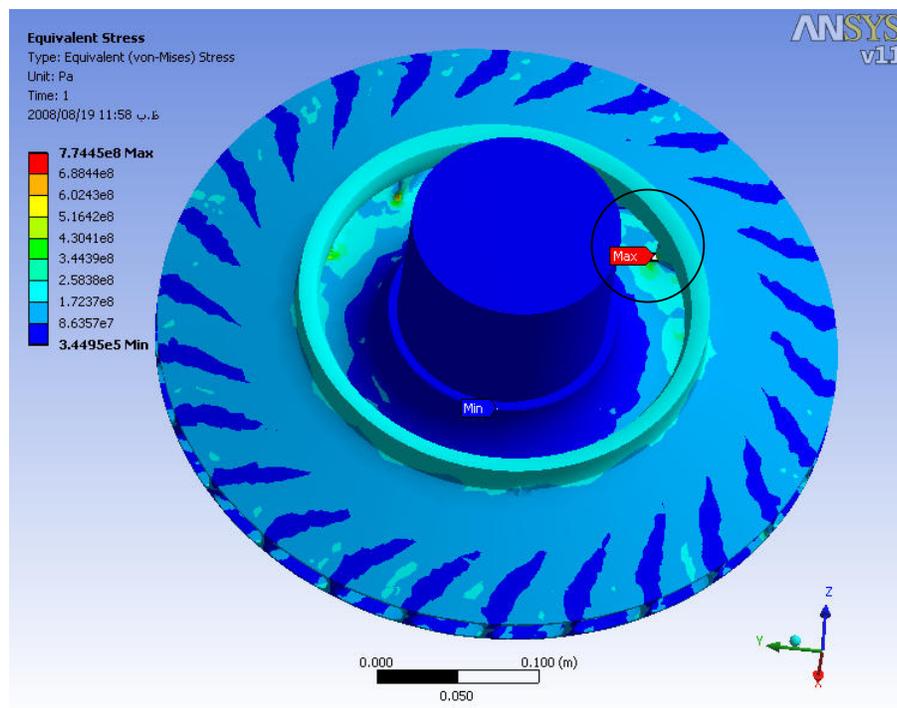
Figure 19: Stress Distribution

Also, these observations were confirmed by mechanical analysis that carried out with Ansys Workbench. Therefore, there is a good agreement between practical and analytical results. These observations illustrate that the failure of this impeller has occurred on the basis of a creep-fatigue mechanism.
